Deepwater Horizon Incident – Internal Investigation
INVESTIGATION UPDATE – INTERIM REPORT

June 08, 2010

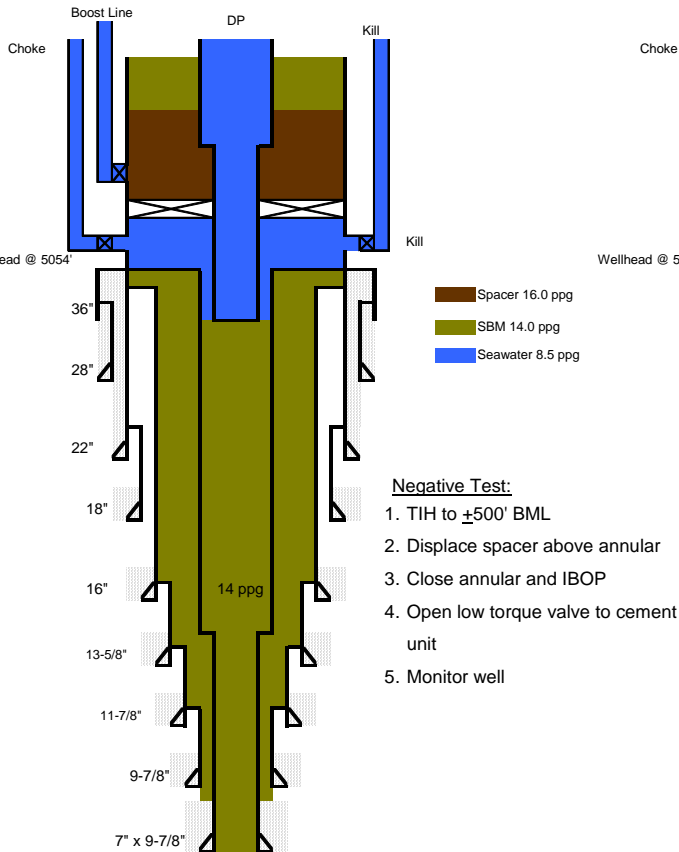
Negative Test Standard Procedure

- Typically negative test to ~500 ft below well head with sea water
 - ✓ ~3300 ft below – stated on MMS permit in order to prevent well head seal area contamination
 - ✓ Imposed additional 1000 psi differential on float equipment/casing/cement
- Where did ~60 bbls from riser go below annular
 - ✓ U-tube up kill line or up drill pipe?
 - ✓ Impacts final negative test pressure applied to well

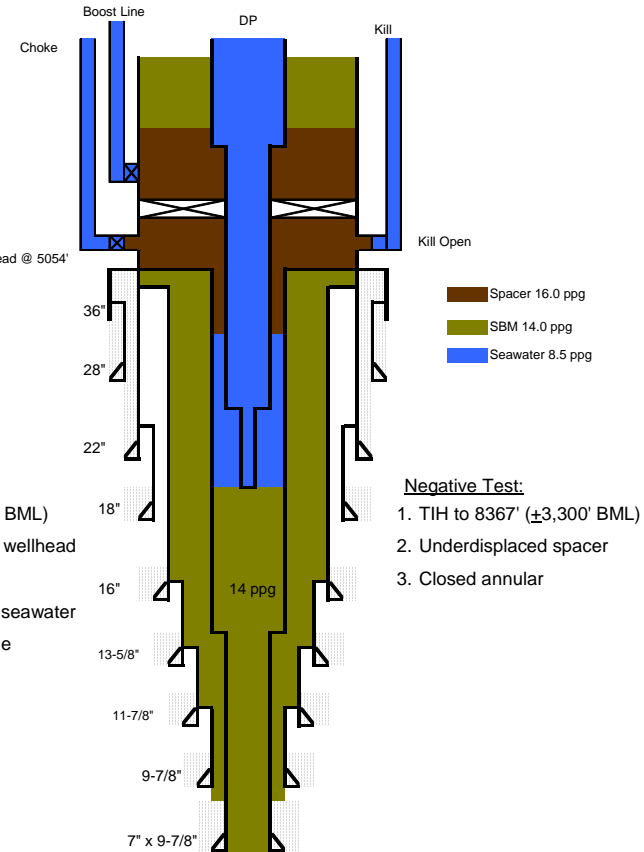
Negative Test Setup at 4/20 17:45

- Set up for negative pressure test began approximately 17:00
 - ✓ ~17:15, 60 barrels of spacer moved below annular
 - ✓ Increased annular activating pressure from 1200 to 1900 psi
 - ✓ Set up fluids through crew handover at 18:00
- Under-displaced 16 ppg spacer
 - ✓ Spacer was not in MMS permit
 - ✓ Position under annular led to confusing pressure readings
 - ✓ Float equipment under tested by 285 psi
- Discussion 18:00-19:00
 - ✓ About fluid volumes due to movement below annular and line up for monitoring – either from drill pipe (normal procedure used by rig) or kill line (MMS permit)
 - ✓ Either line up is appropriate and will correctly monitor well

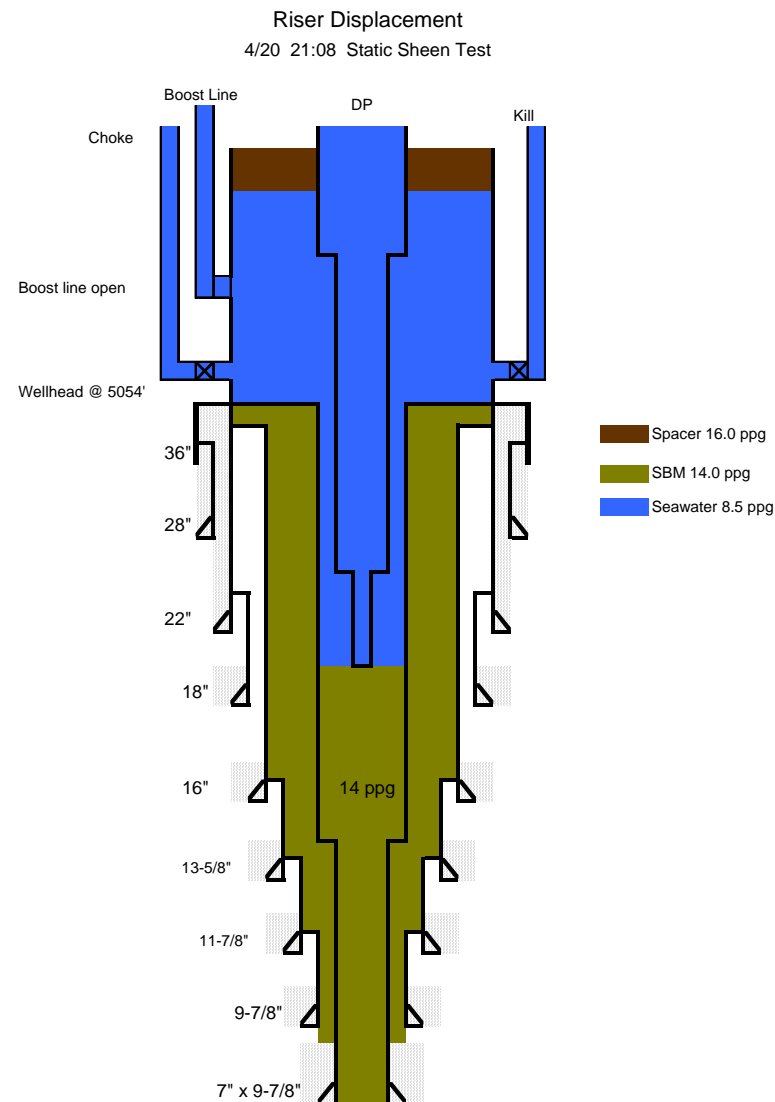
- **Circulate out riser 20:00 to 21:08**
 - Mud circulation out prior to second plug – well reaches highest underbalanced pressure to this point
 - Shut down for static sheen test to begin going over board with water-based spacer
- **Areas of Investigation**
 - Flow changes and volumes
 - Mud transfers
 - Flow sensors accuracy
 - ✓ *Require Sperry Sun system set up details and calibration records*

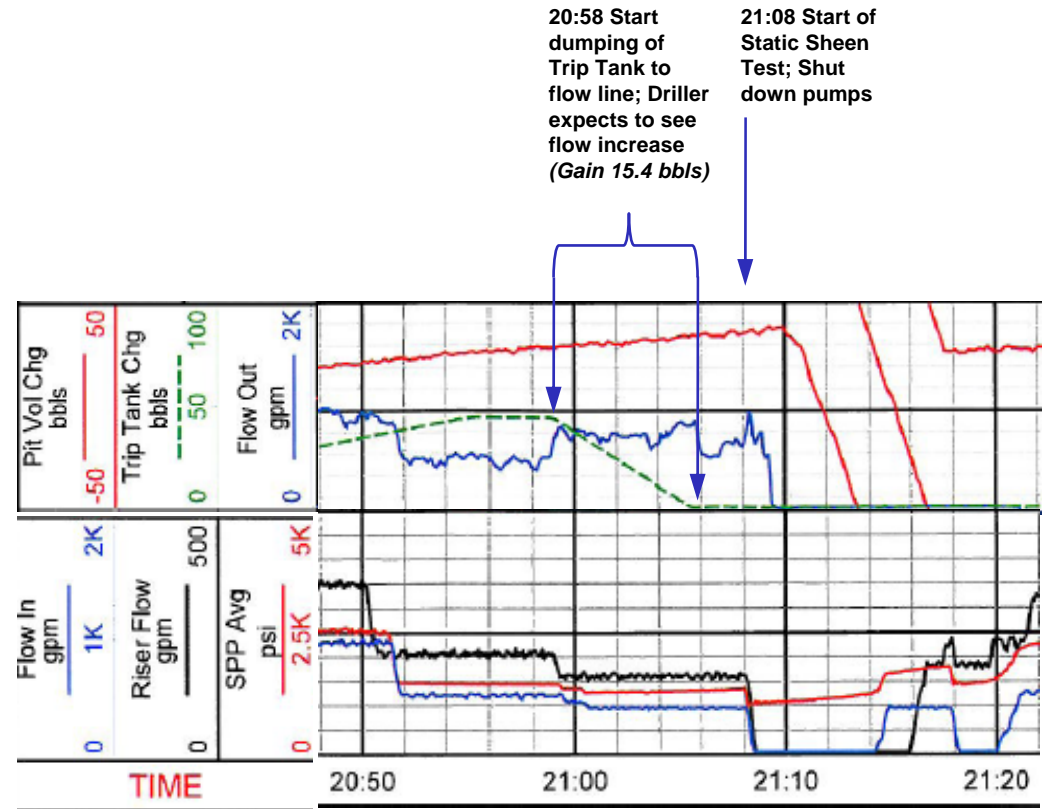
Source: BP OCS-G 32306 001 ST00BP01 Mississippi Canyon 252 Macondo, Last 2 hours before end of transmission

- Trip tank being discharged to pits through flow line (normal procedures ahead of change from oil to water mud in active system)
 - ✓ At same point pumps ramp down for stop at static sheen test
- Increased flow out due to discharge of trip tank
 - ✓ Driller expected to see flow increase
 - ✓ Flow returned near pre-tank discharge level when trip tank pump stopped, THEN increased
 - ✓ Potentially masked the gain

- Complete review of all volumes and real time data (received 5/24)
- Use of trip tank in operation
- Sperry Sun sensors failure to record a flow out after 21:10

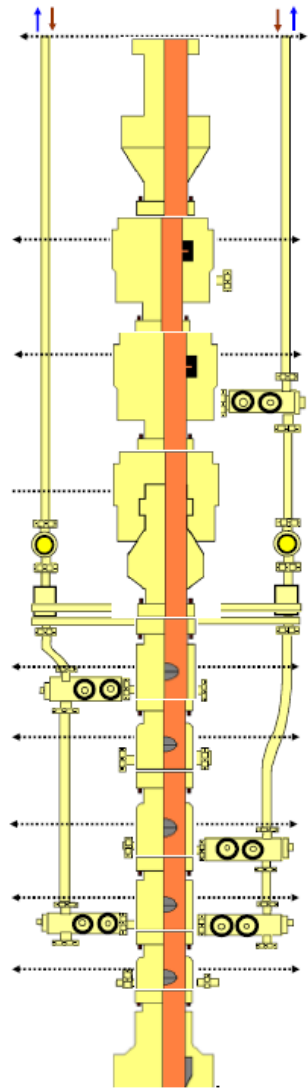
- Witness stated pieces of rubber returned in mud flow over shakers
- Estimated to be from stripping operations during well control event (~1300 ft pipe stripped)
- Expected normal wear on lower annular rubber element
- Annular passed subsequent pressure test on 10 April (250psi/3500psi)

- Lower annular & diverter closed prior to explosion (witness statements)
 - ✓ *Visual indications on Toolpusher panel*
 - ✓ *Fluid seen coming from diverter line by rig & boat crew (diverter confirmation)*
 - ✓ *Flow subsided and then started again (annular confirmation)*
 - ✓ *Last pressure reading over 5400 psi and exceeds lower annular rating of 5000 psi*
- Evidence of upper pipe ram activation
- Potential for multiple tubulars in BOP at time of incident

- Full control system software review
 - ✓ *Software code requested from manufacturer for investigation*
- Review of data from ROV intervention
- Assemble 10-yr history of BOP maintenance, modifications, & upgrades

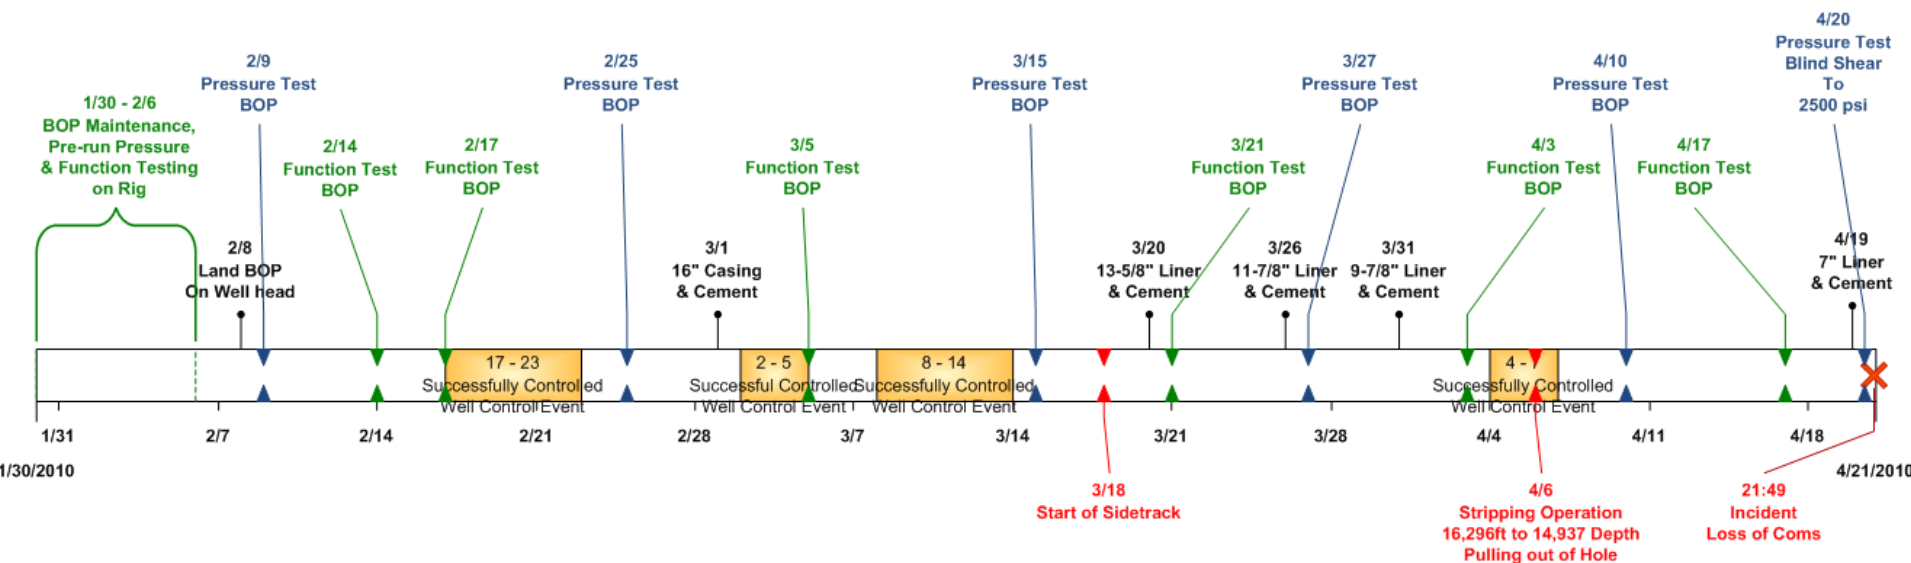
- **Function Test**
 - Preventers activated individually from surface to confirm commands perform subsea
 - No pressure applied
 - Required every 7 days
- **Pressure Test**
 - Preventers activated individually from surface
 - Pressure applied individually to maximum anticipated well bore pressure (*per Operator or MMS*)
 - Required every 14 days
- **Timeline of tests from start of drilling – all tests passed** (*source: IADC reports*)
