Deepwater Horizon Incident – Internal Investigation
INVESTIGATION UPDATE – INTERIM REPORT

June 08, 2010

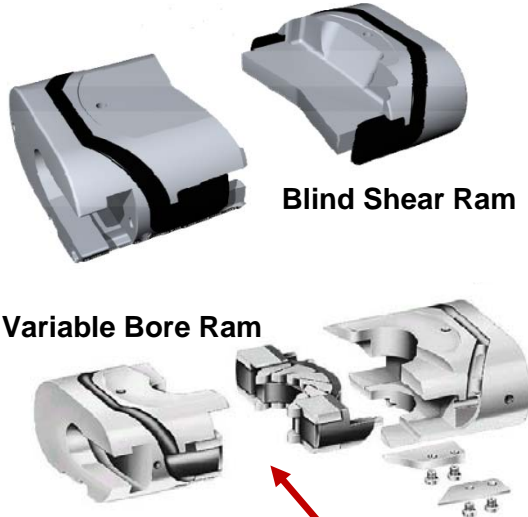
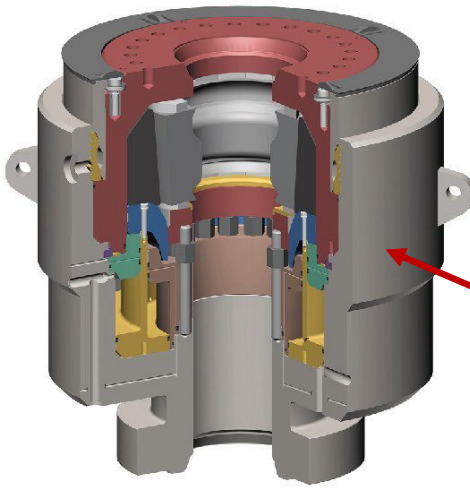
Blowout Preventer

RISER ADAPTER
 UPPER ANNULAR
 LOWER ANNULAR

LMRP CONNECTOR
 BLIND SHEAR RAM
 CASING SHEAR
 3 1/2 TO 6 5/8 VBR
 3 1/2 TO 6 5/8 VBR
 3 1/2 TO 6 5/8 VBR Test Ram
 TOP OF WELLHEAD
